Test report

12.TR.034/DJ

**20° - 100 km/h Sign post test according
to EN 12767:2007**

Date 14 March 2012
Author D. Jansen
Client Impact Recovery Systems, Inc.
4955 Stout Drive
San Antonio
Texas, 78219
USA

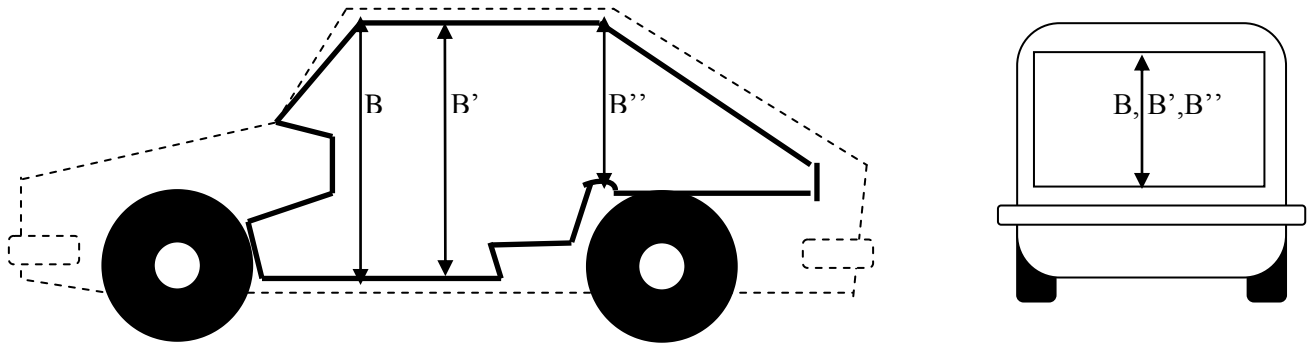
Appendix D Roof deformation results

MEASURED on LHS

Before [mm]	After [mm]	Result [mm]
B. Roof behind windscreen close to horizontal – floor	978	979	+1
B' Roof in line with B-pillar – floor panel	1043	1043	0
B'' Roof in front of rear window close to hor. – floor	801	800	-1
