TECHNICAL MEMORANDUM

Contract No.: 1903665
Test Report No.: 613301-01-2
Project Name: Impact Recovery Systems, Inc. OmegaPost™ 2 High Performance Delineator – TTCD-2019-01-001 – High Speed Applications
Sponsor: AASHTO National Transportation Product Evaluation Program (NTPEP)

This tech memo documents the testing of Impact Recovery Systems, Inc OmegaPost™ High Performance delineators installed on concrete and asphalt.

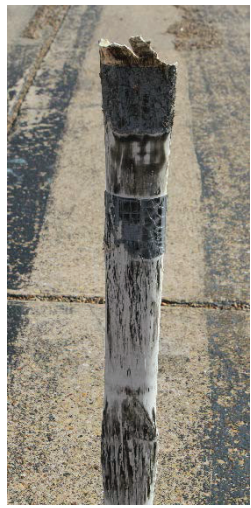
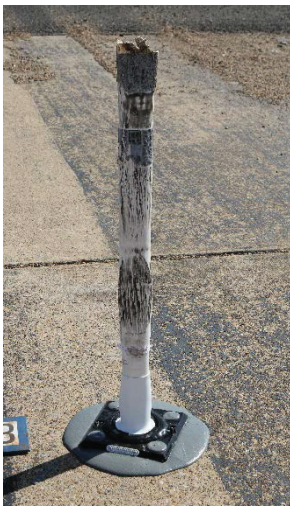
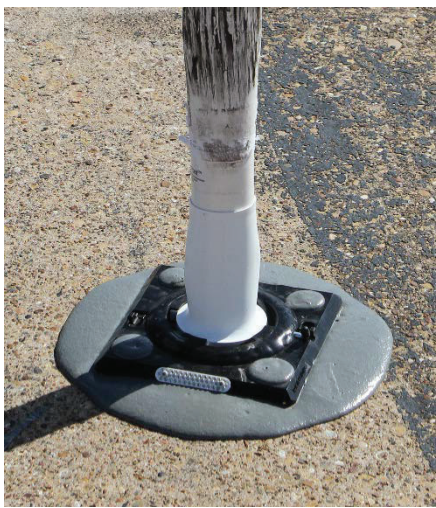
Table B5. Delineator #2B after Specific Runs for Test No. 613301-01-2			
Photos – Post #2B (Concrete Glue-Down)			
Run #	Reflective Sheeting	Full Post	Base or Damage
Run #200

The delineators attached to concrete with epoxy completed 200 runs with no failure.
