IMPACT RECOVERY SYSTEMS
 PED-IN-A-BAG™ CRASH TEST REPORT
 MARCH 2012

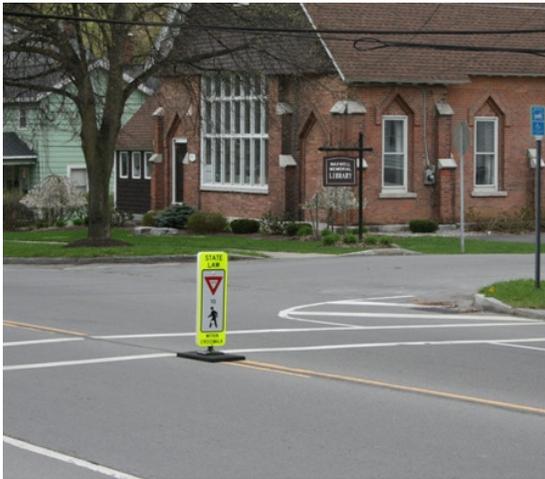
Product tested was a standard Ped-in-a-Bag™ Pedestrian sign, 12” x 36” with a standard yellow 110 spring assembly. Base used was a 20 pound lightweight portable. Sample is representative of a standard production model, although sheeting applied was obsolete but deemed to have no impact on crash testing mechanical results.

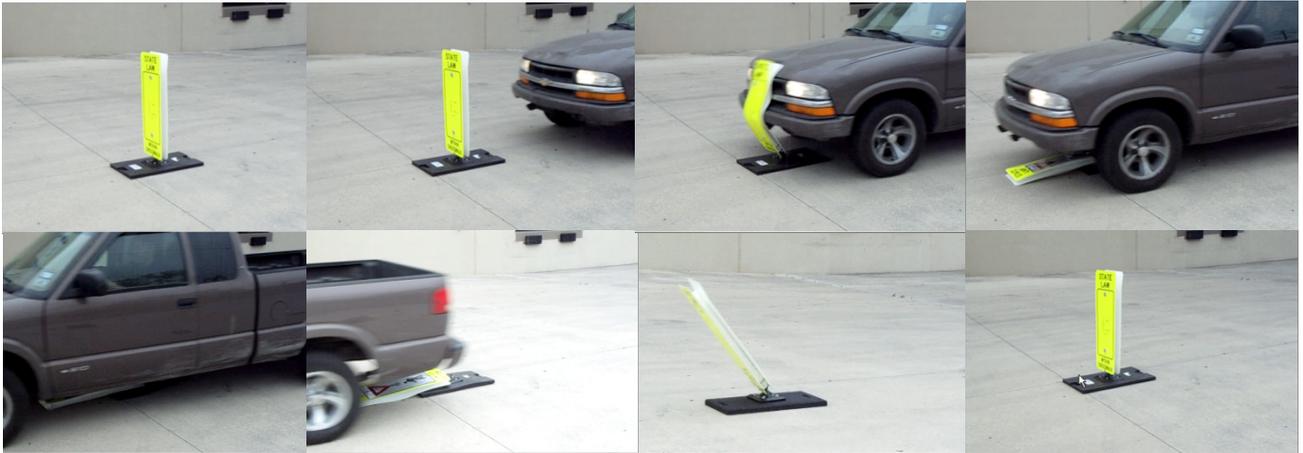
Below is a representation of a 20 mph bumper strike:

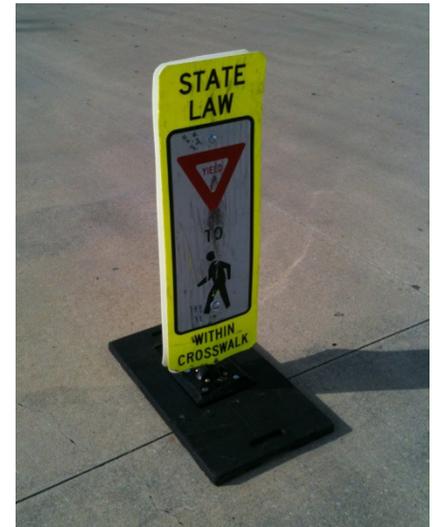
Figure 1 - Through 14 Impacts

Initial testing through 14 impacts was at or below design criterion. The sign exhibited the expected results, giving upon impact and returning upright. Several times re-positioning of the base was required to continue.

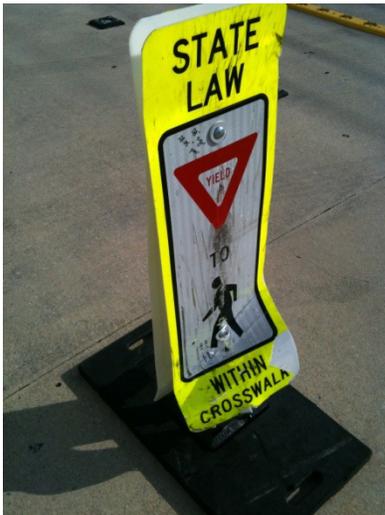
Figure 2 - Through 18 Impacts

Impacts 15-18 were more extreme, including one 25 mph strike and an off-angle strike. Damage to the lower portion of the sign can be seen in Figure 2. The spring mechanism and base are fully functional, however.

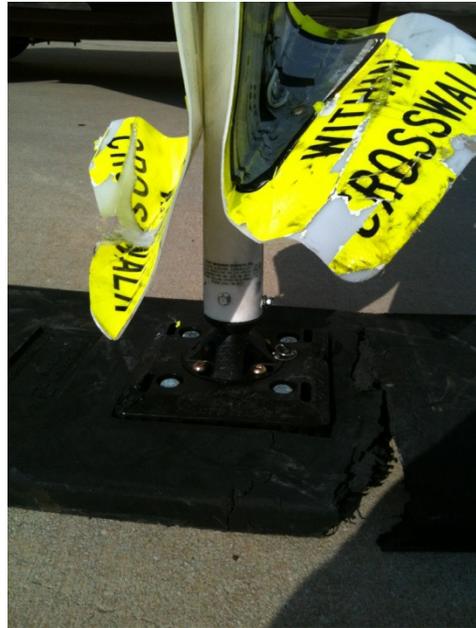
Figure 3 - Tested to Failure Mode

Final testing was intended to produce a failure of the product to determine failure modes. Strikes above 20 mph induced base drag beneath the vehicle. Also, previous damage to the lower sheeting was exacerbated.

Final failure was caused by a catching of the base under the bottom of the vehicle. Although the sign would continue to serve its purpose, it would no longer behave as intended upon impact. Spring and post mechanisms were intact.
