WHITE PAPER:

Successful Implementation of Station Platform Between Car Barriers

Presented at the Transportation Research Board 93rd Annual Meeting, January 2014
Corresponding Author: Sue Reiss

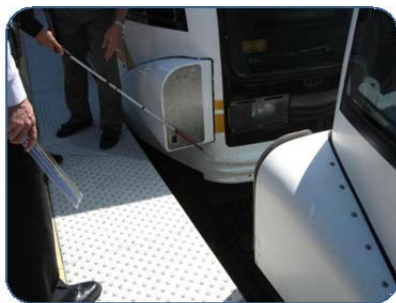
Exhibit 6

The most innovative design attempt was a **light beam** experiment (Exhibit 6). This was by far the most technologically intensive advanced attempt made and hopes were high that it would succeed. It included a steady and continuous light beam between a coupled set of vehicles. If the beam were broken by a cane, leg, or any solid device, a loud alarm would be sounded as a “warning”.

Although it worked perfectly inside the maintenance facility during the testing phase, it failed miserably on its first test trip on the Gold Line. The independent suspension airbags on each coupled vehicle which float in opposing directions broke the light beam. This resulted in the activation of a loud and unpleasant horn that could be heard by all residents and passengers within 200 feet. In addition, the beam was found to occasionally wrap around the tip of a cane (often used by the visually impaired) and as a result, would not set off the alarm. Staff was disappointed and went back to the drawing board. This time the canvas for the drawing had to be relocated from the car to the platform.

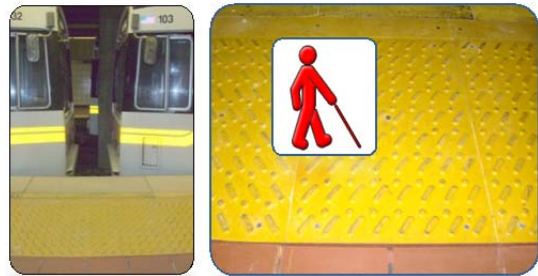
Exhibit 7

The first platform prototype design was a **tactile floor mat** which communicated a “stay away” warning location. Once visually impaired riders were educated to its meaning, it was thought that the problem would be solved. LACMTA staff attempted to satisfy the LACMTA Accessibility Advisory Committee (AAC) with several mat designs containing creative ridge curves and depths. The AAC was initially satisfied; a preliminary pattern (Exhibit 7) was selected and installed at Union Station on the Red Line.

A public hearing was then held to ensure all the voices throughout Los Angeles County were heard. Unfortunately, the organizations representing the blind rejected the mat and convinced the AAC to disallow the mat design as well. Their position was that in a global context, patterned mats are often used to communicate where the visually impaired are to stand, as opposed to a location that warns one to stay away from hazards. In essence, the mat could be communicating the wrong message and yield fatal results. There was also the issue that some riders may not be able to feel the ridged design in addition to their sight impairment.

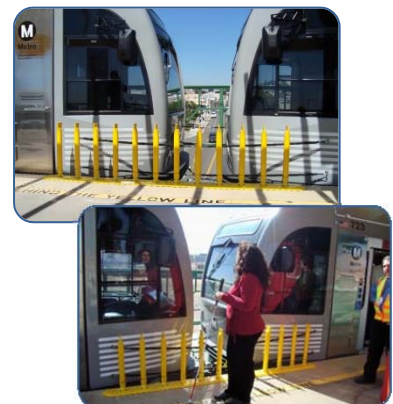
Exhibit 9

That same meeting did result in a request of LACMTA to design a **vertical barrier on the platform**, which would not only warn, but also prevent one from falling between the cars of a coupled train. LACMTA concluded that a set of vertical thin bollards spaced in such a way to span not only the distance of the gap, but wide enough to allow for stopping variability should a train berth approximately 6 feet outside its targeted stop point, while avoiding blocking the door sets closest to the car ends.

The cooperative approach utilized allowed for the development of a product that would ultimately satisfy all agency, regulatory, ADA and maintenance concerns. IRS designed and fabricated a set of bollards and delivered them within just a few weeks (Exhibit 8 and Exhibit 9).
