WHITE PAPER:

# Successful Implementation of Station Platform Between Car Barriers

Presented at the Transportation Research Board 93<sup>rd</sup> Annual Meeting, January 2014  
Corresponding Author: Sue Reiss

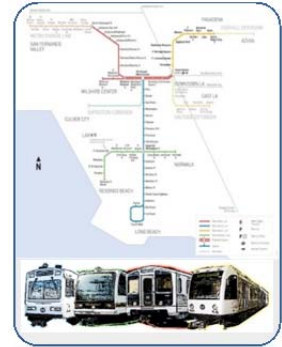
**Exhibit 1**

The Blue Line, the first modern rail system in Los Angeles opened in 1990. Two vehicle types totaling 69 LRVs were purchased for this line, both manufactured by Sumitomo Nippon-Sharyo. The first 54 vehicles are referred to as the P-865 cars and a second 15-vehicle order, essentially identical in design, were referred to as the P2020 vehicles. Since the BCB federal regulations became law after these vehicles were placed in service, none have ever been equipped with carborne BCBs.

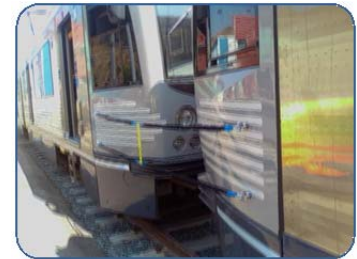
*Exhibit 5*

The BCB regulations are designed for “on vehicle” BCB devices, as opposed to a station platform method, to protect the gaps between vehicles. Although numerous attempts to design a carborne device were made, all attempts failed. One failed attempt included the use of **long bungee cords** attached to the P2550; however, the car taper was so great that the cords were too long and flimsy to provide a rigid barrier (Exhibit 5).

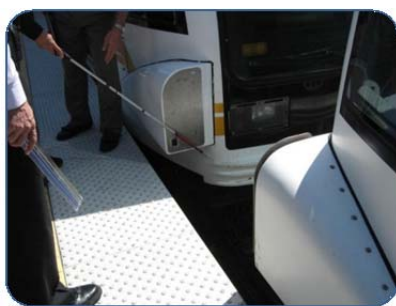
*Exhibit 6*

The most innovative design attempt was a **light beam** experiment (Exhibit 6). This was by far the most technologically intensive advanced attempt made and hopes were high that it would succeed. It included a steady and continuous light beam between a coupled set of vehicles. If the beam were broken by a cane, leg, or any solid device, a loud alarm would be sounded as a “warning”.

Although it worked perfectly inside the maintenance facility during the testing phase, it failed miserably on its first test trip on the Gold Line. The independent suspension airbags on each coupled vehicle which float in opposing directions broke the light beam. This resulted in the activation of a loud and unpleasant horn that could be heard by all residents and passengers within 200 feet. In addition, the beam was found to occasionally wrap around the tip of a cane (often used by the visually impaired) and as a result, would not set off the alarm. Staff was disappointed and went back to the drawing board. This time the canvas for the drawing had to be relocated from the car to the platform.

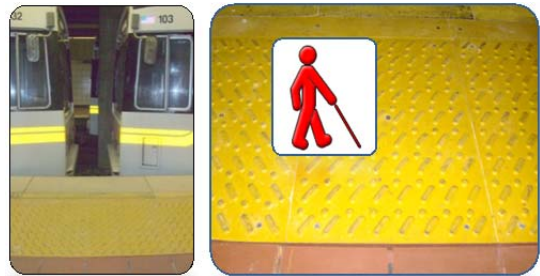
Exhibit 7

The first platform prototype design was a **tactile floor mat** which communicated a “stay away” warning location. Once visually impaired riders were educated to its meaning, it was thought that the problem would be solved. LACMTA staff attempted to satisfy the LACMTA Accessibility Advisory Committee (AAC) with several mat designs containing creative ridge curves and depths. The AAC was initially satisfied; a preliminary pattern (Exhibit 7) was selected and installed at Union Station on the Red Line.

A public hearing was then held to ensure all the voices throughout Los Angeles County were heard. Unfortunately, the organizations representing the blind rejected the mat and convinced the AAC to disallow the mat design as well. Their position was that in a global context, patterned mats are often used to communicate where the visually impaired are to stand, as opposed to a location that warns one to stay away from hazards. In essence, the mat could be communicating the wrong message and yield fatal results. There was also the issue that some riders may not be able to feel the ridged design in addition to their sight impairment.

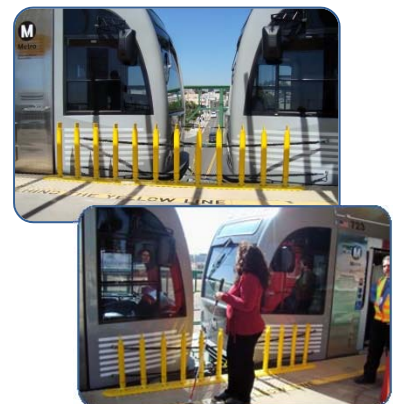
Exhibit 9

The cooperative approach utilized allowed for the development of a product that would ultimately satisfy all agency, regulatory, ADA and maintenance concerns. IRS designed and fabricated a set of bollards and delivered them within just a few weeks (Exhibit 8 and Exhibit 9).

That same meeting did result in a request of LACMTA to design a **vertical barrier on the platform**, which would not only warn, but also prevent one from falling between the cars of a coupled train. LACMTA concluded that a set of vertical thin bollards spaced in such a way to span not only the distance of the gap, but wide enough to allow for stopping variability should a train berth approximately 6 feet outside its targeted stop point, while avoiding blocking the door sets closest to the car ends.

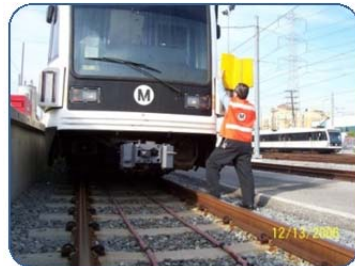
**Exhibit 11**

The benefits have been greater than anticipated. Labor was reduced by eliminating the need to dispatch maintenance staff to the field to couple/uncouple trains when consistent sizes are adjusted to meet service demands and timetables. Additionally, there is no longer a need to maintain the mountings and paddles for the P2000 vehicles, which had resulted in considerable costs and several injury claims when installing or removing these large paddles (Exhibit 11).

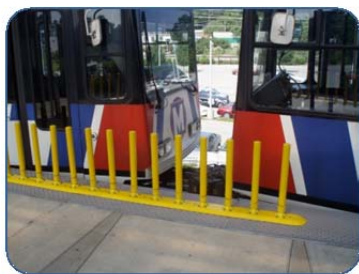
*St. Louis*

Development of the platform BCBs benefitted not only LACMTA but other properties as well. Subsequent to LACMTA's actions, Francisco MUNI underwent a platform BCBs test period with the CPUC. Although they passed the test, MUNI has not yet equipped their high level platforms with the BCB system. However, high level platform rail systems in St. Louis, Pittsburgh, Buffalo, Santa Clara, and even a low floor rail system in Charlotte have installed BCBs that are identical in design and procured from IRS as those installed by LACMTA.

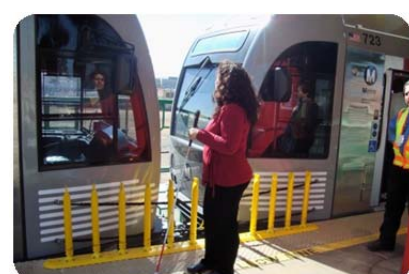
*Los Angeles*

After ten years of effort, an effective and sustainable solution was found. Since installation, there have been issues with vandalism and breaking of the bollards; however, they have been minimal and well within reasonable expectations of maintenance requirements. IRS has since redesigned their BCBs to withstand greater impacts and include more accessories such as reflectors at the top of some of the bollards.
