TECHNICAL MEMORANDUM

Contract No.: 1903665
Test Report No.: 613301-01-2
Project Name: Impact Recovery Systems, Inc. OmegaPost™ 2 High Performance Delineator – TTCD-2019-01-001 – High Speed Applications
Sponsor: AASHTO National Transportation Product Evaluation Program (NTPEP)

This tech memo documents the testing of Impact Recovery Systems, Inc OmegaPost™ High Performance delineators installed on concrete and asphalt.

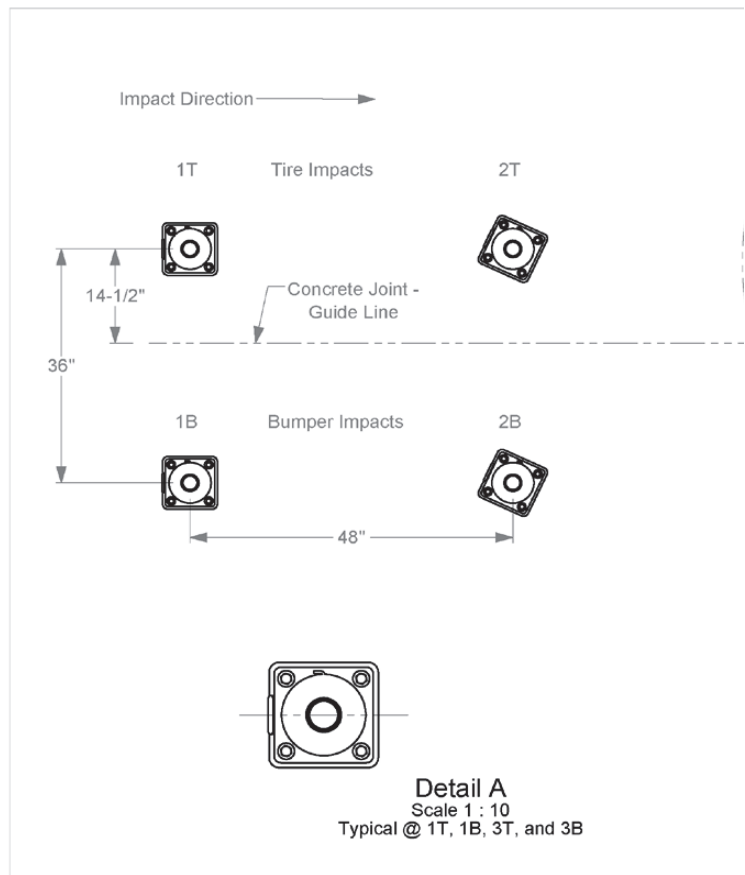
The delineators attached to concrete with epoxy completed 200 runs with no failure.

Delineator Post	Run Number	Failure Mode
Glue-Down on Concrete	1T	200	No failure
	1B	200	No failure
	2T	200	No failure
	2B	200	No failure
